ON THE MOVE

PRODUCT BULLETIN

Subject: Repeated Misfire DTC's failures of COP coil, boots, and wire sets.

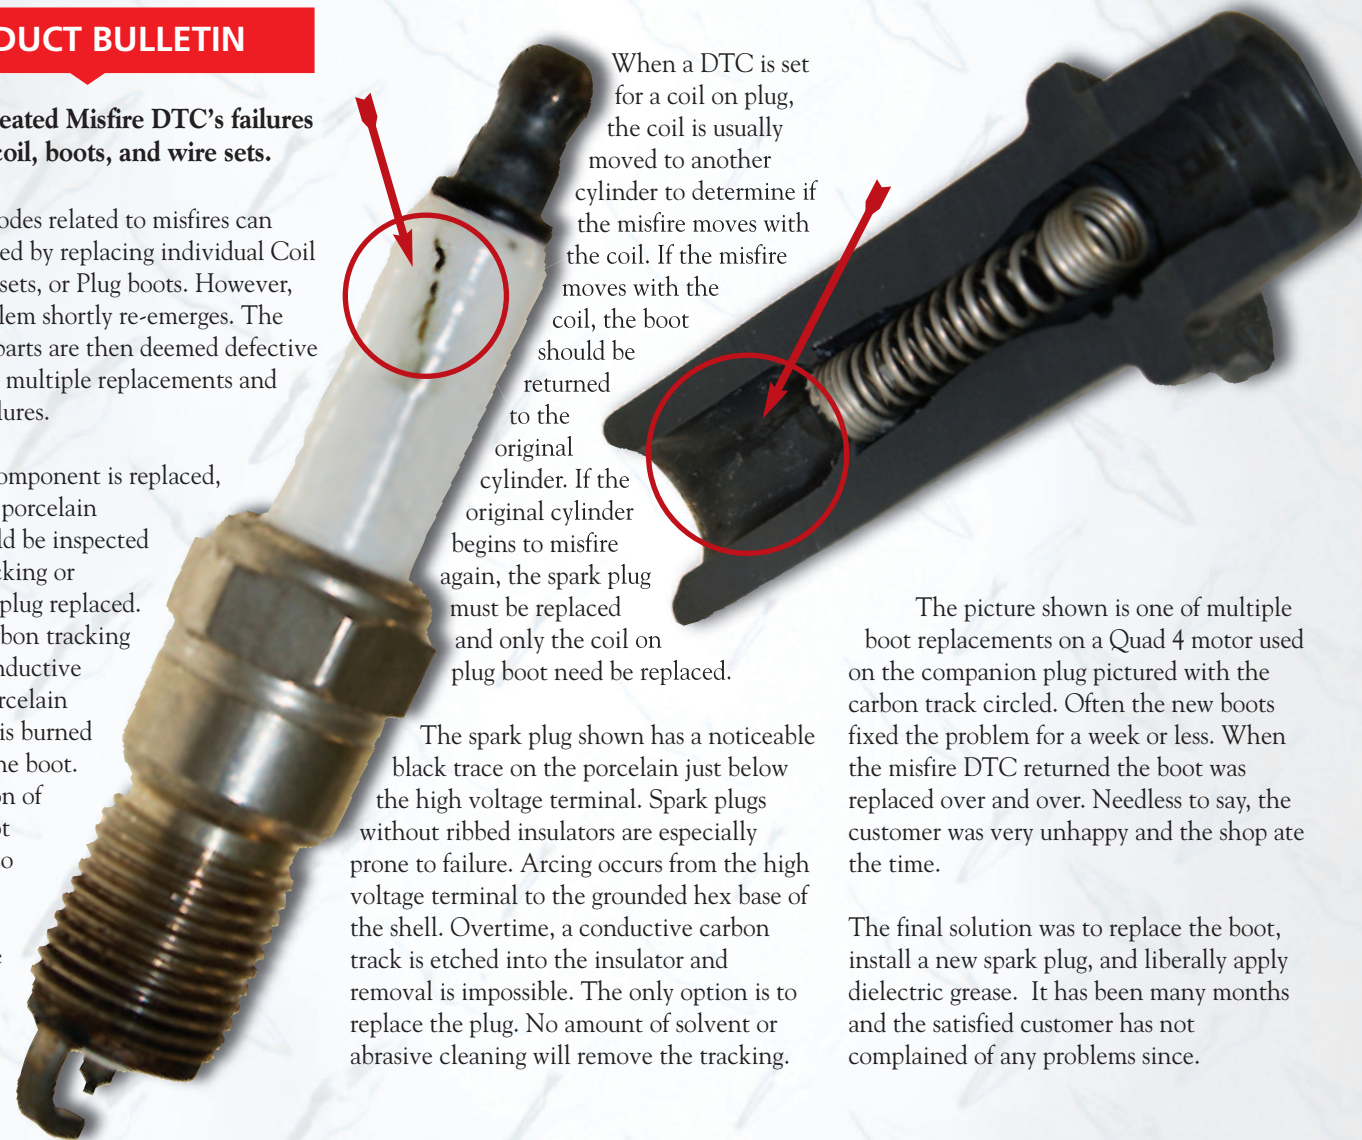
Whenever a component is replaced, the spark plug porcelain insulator should be inspected for carbon tracking or preferably the plug replaced. Over time, carbon tracking will burn a conductive path in the porcelain which in turn is burned into the silicone boot. The application of dielectric "boot grease" will also help prevent future failures when both the new boot and spark plug are replaced.

The spark plug shown has a noticeable black trace on the porcelain just below the high voltage terminal. Spark plugs without ribbed insulators are especially prone to failure. Arcing occurs from the high voltage terminal to the grounded hex base of the shell. Overtime, a conductive carbon track is etched into the insulator and removal is impossible. The only option is to replace the plug. No amount of solvent or abrasive cleaning will remove the tracking.

The picture shown is one of multiple boot replacements on a Quad 4 motor used on the companion plug pictured with the carbon track circled. Often the new boots fixed the problem for a week or less. When the misfire DTC returned the boot was replaced over and over. Needless to say, the customer was very unhappy and the shop ate the time.

The final solution was to replace the boot, install a new spark plug, and liberally apply dielectric grease. It has been many months and the satisfied customer has not complained of any problems since.

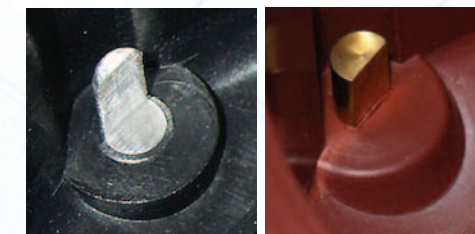
Cut (left) & Molded Terminals

Al: These two styles of manufacture are essentially equal. With any cap it is important to insure a true concentric circle from the center for the Rotor to spin in and have the coil's charge jump to the terminals. When distributor caps first came into being, most were molded with the terminals installed in the mold prior to injecting the plastic. Then it is set up into a metal cutting lathe and the terminals machined to the correct radius. This is a fairly expensive step and requires a skilled person to perform this operation. As molding methods improved and as-molded accuracy became the norm, many caps, when being re-tooled, started using a molded part that had sleeves and slots for the stamped terminals to go into. A tight fit on the round shaft insures a water tight terminal, and a very accurately molded slot at the interior allows the flat stamped end to be positioned a just the right radius for the design. Molding speed of the plastic part increased because no parts had to be hand inserted into the mold, and a factory worker could insert the terminals quickly and accurately without needing a machinist's skills.
