ON THE MOVE

Igniters live on!

On the Move! April 2017

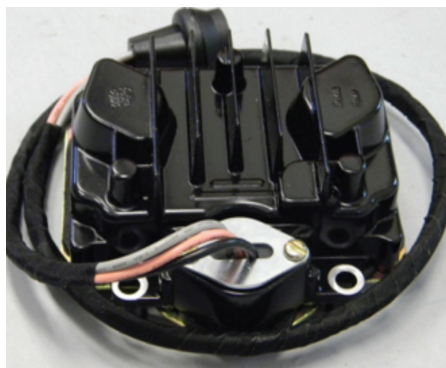
Do you know me?

GM "Delcotronic" module-amplifier from 1963. Used on the optional electronic ignition available on Corvette and some Pontiac modules. A decade ahead of the early '70's mass introduction of the technology as "standard equipment".

Based on our "theme" this month you've probably guessed it's a module – but to what and when?
